**The Application of Infrared Thermography
to Condition Assessments of Guastavino Vaulting**

The Application of Infrared Thermography to Condition Assessments of Guastavino Vaulting

2. West Side Market, Cleveland, Ohio

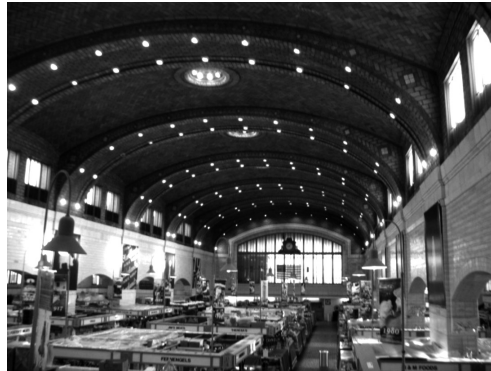
FIG. 1

A view of the main market hall of the West Side Market looking east.

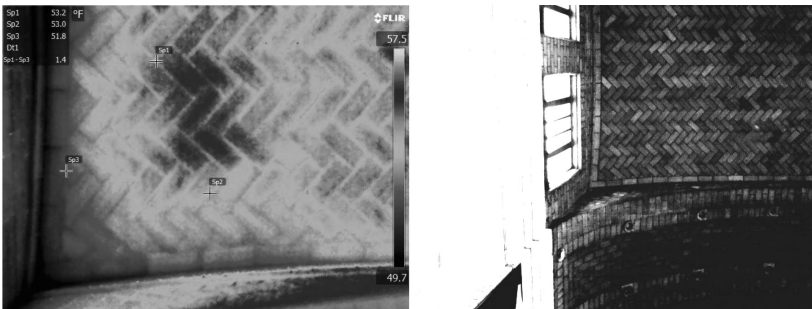
FIG. 6

A second type of anomaly was consistently observed near the corners of about 50% of the vaults. These anomalies were observed during both winter season (Fig. 6) and during the summer season. The Guastavino vaults have an additional layer of tile installed at the perimeter of the vault (Fig. 7). The anomaly occurs at the limit of the additional layer of tile at the perimeter.

A view of the West Side Market ceiling vault with the IRT image to the left and the optical image to the right. The image was taken during the winter season, with the anomaly showing as a warm area.

No sounding of the vaults was conducted during this preliminary investigation, but it is speculated that the anomalies in the corners of the vault are associated with dimensional changes in the clay masonry. Clay masonry is assumed to undergo moisture expansion following construction of 0.0005 in/in or 0.0000072 mm/mm (3). While the expansion across the 16 feet bay width (4.9 m) is very small, expansion along the 50 feet span (15.4 m) is anticipated to be 1/3 of an inch (3/4 cm). Such expansion following construction likely caused the vault crown to rise slightly, relieving the stress, but at the vault corners such expansion forces would create shear stresses. It is speculated that the observed anomalies are local delaminations associated with the expansion of clay masonry.

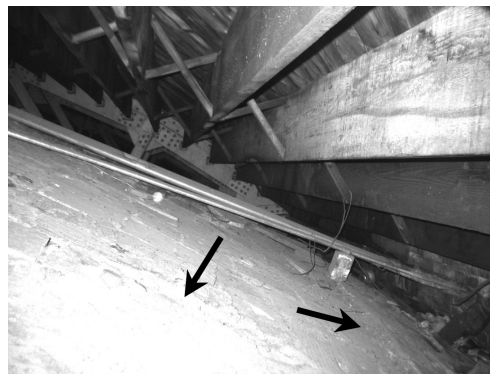
FIG. 7

A view of the West Side Market ceiling vault extrados. The black arrows indicate the limit of the additional layer of tile installed at the perimeter.
